TECHNICAL MEMORANDUM

Project No. CA-GLD-1791470A

CBM Aggregates

HEADWATER DRAINAGE FEATURE ASSESSMENT - PROPOSED CBM ABERFOYLE SOUTH LAKE PIT

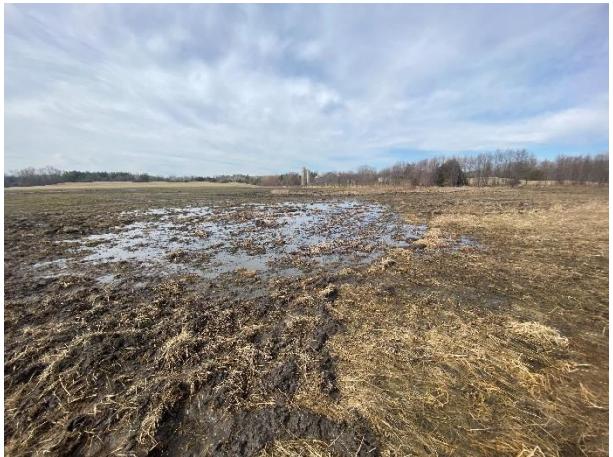
- **HDF1:** Channelized through active cropland; native vegetation, contributing terrestrial habitat, but no direct fish use. This feature was actively flowing during the spring field assessment, conveying flow from the agricultural field.
- **HDF2:** Swale through active cropland; native vegetation, contributing terrestrial habitat, but no direct fish use. This feature was actively flowing during the spring field assessment, conveying flow from the agricultural field.

Photo 1: HDF1 taken 2025-03-19 during Sample Event 1 – Spring Freshet. Photo looking northeast from the agricultural field.

- Maintain overall water balance by implementing mitigation measures to promote infiltration of rainwater runoff.
- Terrestrial features have been assessed in the Natural Environment Report Proposed Aberfoyle South Pit Expansion (WSP 2023b) and there are no notable terrestrial functions associated with them.

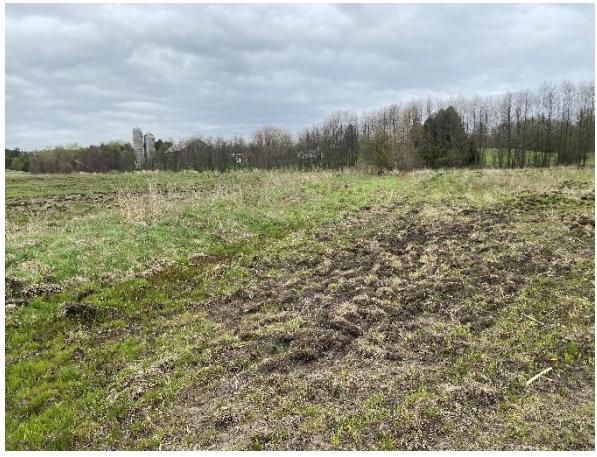
Photo 2: HDF1 taken 2025-05-05 during Sample Event 2 – Spring Spate. Photo looking northeast from the agricultural field.

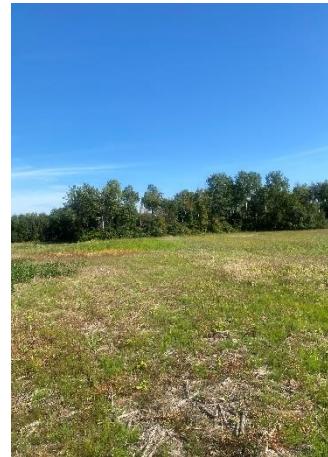
Photo 3: HDF1 taken 2024-08-30 during Sample Event 3 – Summer. Photo looking northeast from the agricultural field.

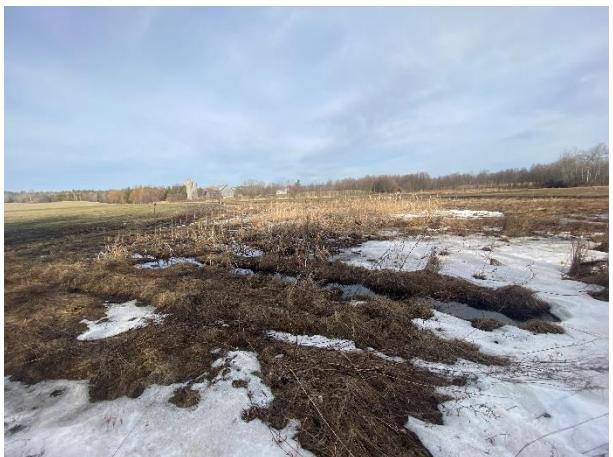
Photo 5: HDF2 taken 2025-03-19 during Sample Event 1 – Spring Freshet. Photo looking northeast from the agricultural field where the HDF started.

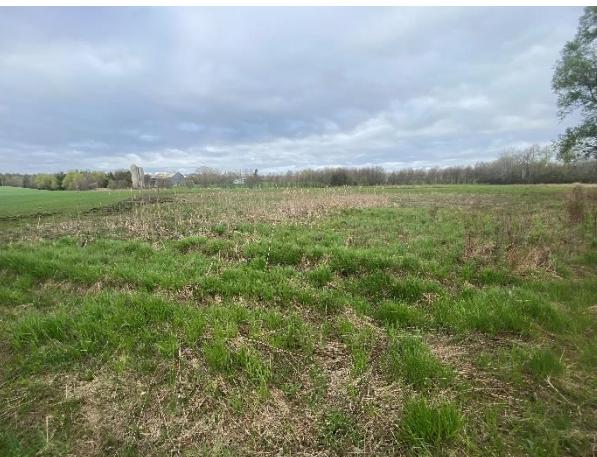
Photo 6: HDF2 taken 2025-05-05 during Sample Event 2 – Spring Spate. Photo looking northeast from the agricultural field where the HDF started.

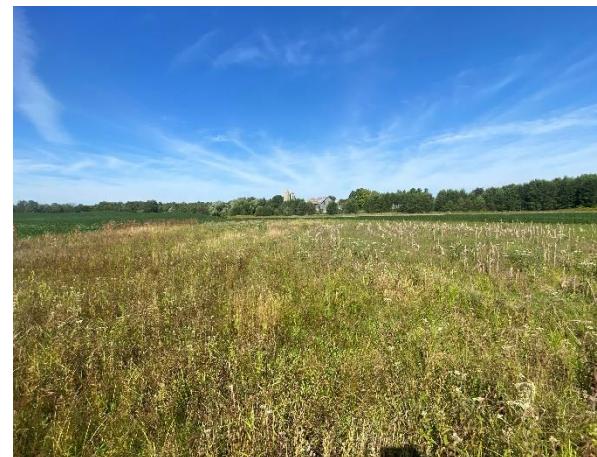
Photo 7 : HDF2 taken 2024-08-30 during Sample Event 3 - Summer. Photo looking northeast from the agricultural field where the HDF started.
